PROJECT FOR THE RESTORATION OF THE DELIMARA LIGHTHOUSE TOWER EXTERNAL MARITIME COLOURS

Current Condition

Methodology for Restoration/Maintenance and repainting of the Tower

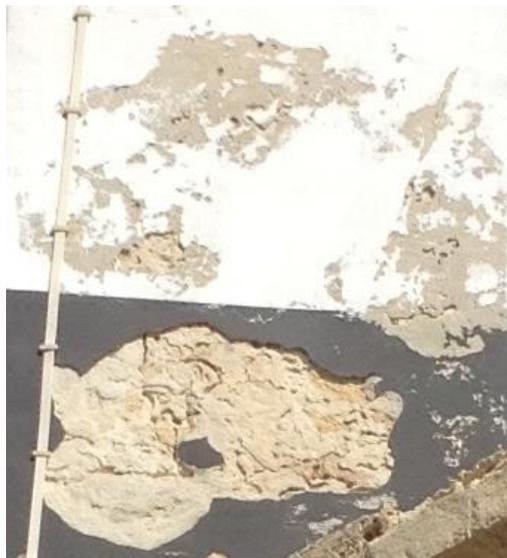
Loss of Plastering

Loss of plaster revealing stone deterioration
in some parts of the lighthouse tower

Deterioration is mainly characterised by the loss of plastering and paint and decay of mortar joints which are exposed to the elements following to the loss of the overlying plaster. In the past cement was used and this also

accelerated the deterioration of the underlying stonework and loss of plaster. It is not excluded that cement plastering which could not be removed in the previous restoration, still exist in some parts.

- Opening and manual cleaning of exposed loose mortar joints.
- Manual cleaning/removal of loose plaster and paint. Any attempt has to be made to preserve as much as possible of the original if this is not loose.
- Repointing of open joints using lime based mixes. Small amounts of white cement or lo-alkali cement may be used with the predominantly hydraulic lime-based mix. This was also included in the approved Full Development Permit Planning Application Number 03884/05.
-
- Plastering of missing parts with a predominantly hydraulic lime based mix. Small amounts of white cement or lo-alkali cement may be used with the predominantly lime-based mix. This was also included in the approved Full Development Permit Planning Application Number 03884/05.
- Painting of the whole tower with breathable black and white paint.

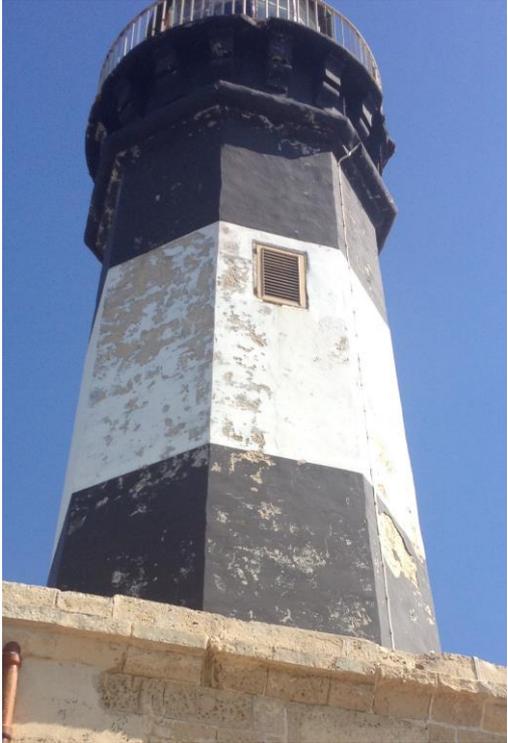
Loss of Paint

Many parts of the tower experienced loss of paintwork since it was last painted 10 years ago. The tower was painted for the first time in black and white stripes in 1950 and lead oil paint was used. This colour scheme was used following a complaint by a Flag Officer of the 1st Cruiser Squadron that the lighthouse was not enough visible during the day.

A breathable paint will be used.
