PROJECT FOR THE RESTORATION OF THE DELIMARA LIGHTHOUSE TOWER EXTERNAL MARITIME COLOURS

Current Condition

Methodology for Restoration/Maintenance and repainting of the Tower

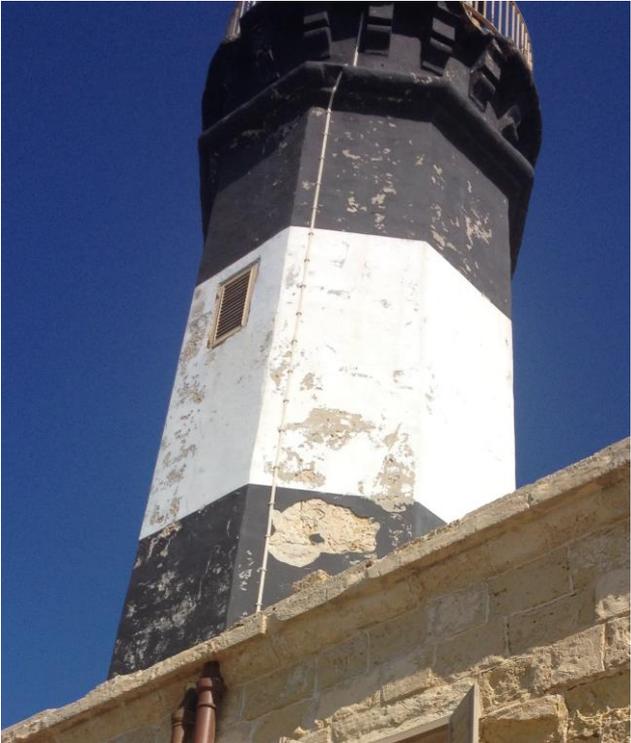
Many parts of the tower experienced loss of paintwork since it was last painted 10 years ago. The tower was painted for the first time in black and white stripes in 1950 and lead oil paint was used. This colour scheme was used following a complaint by a Flag Officer of the 1st Cruiser Squadron that the lighthouse was not enough visible during the day.

A breathable paint will be used.

- Opening and manual cleaning of exposed loose mortar joints.
- Manual cleaning/removal of loose plaster and paint. Any attempt has to be made to preserve as much as possible of the original if this is not loose.
- Repointing of open joints using lime based mixes. Small amounts of white cement or lo-alkali cement may be used with the predominantly hydraulic lime-based mix. This was also included in the approved Full Development Permit Planning Application Number 03884/05.
-
- Plastering of missing parts with a predominantly hydraulic lime based mix. Small amounts of white cement or lo-alkali cement may be used with the predominantly lime-based mix. This was also included in the approved Full Development Permit Planning Application Number 03884/05.
- Painting of the whole tower with breathable black and white paint.

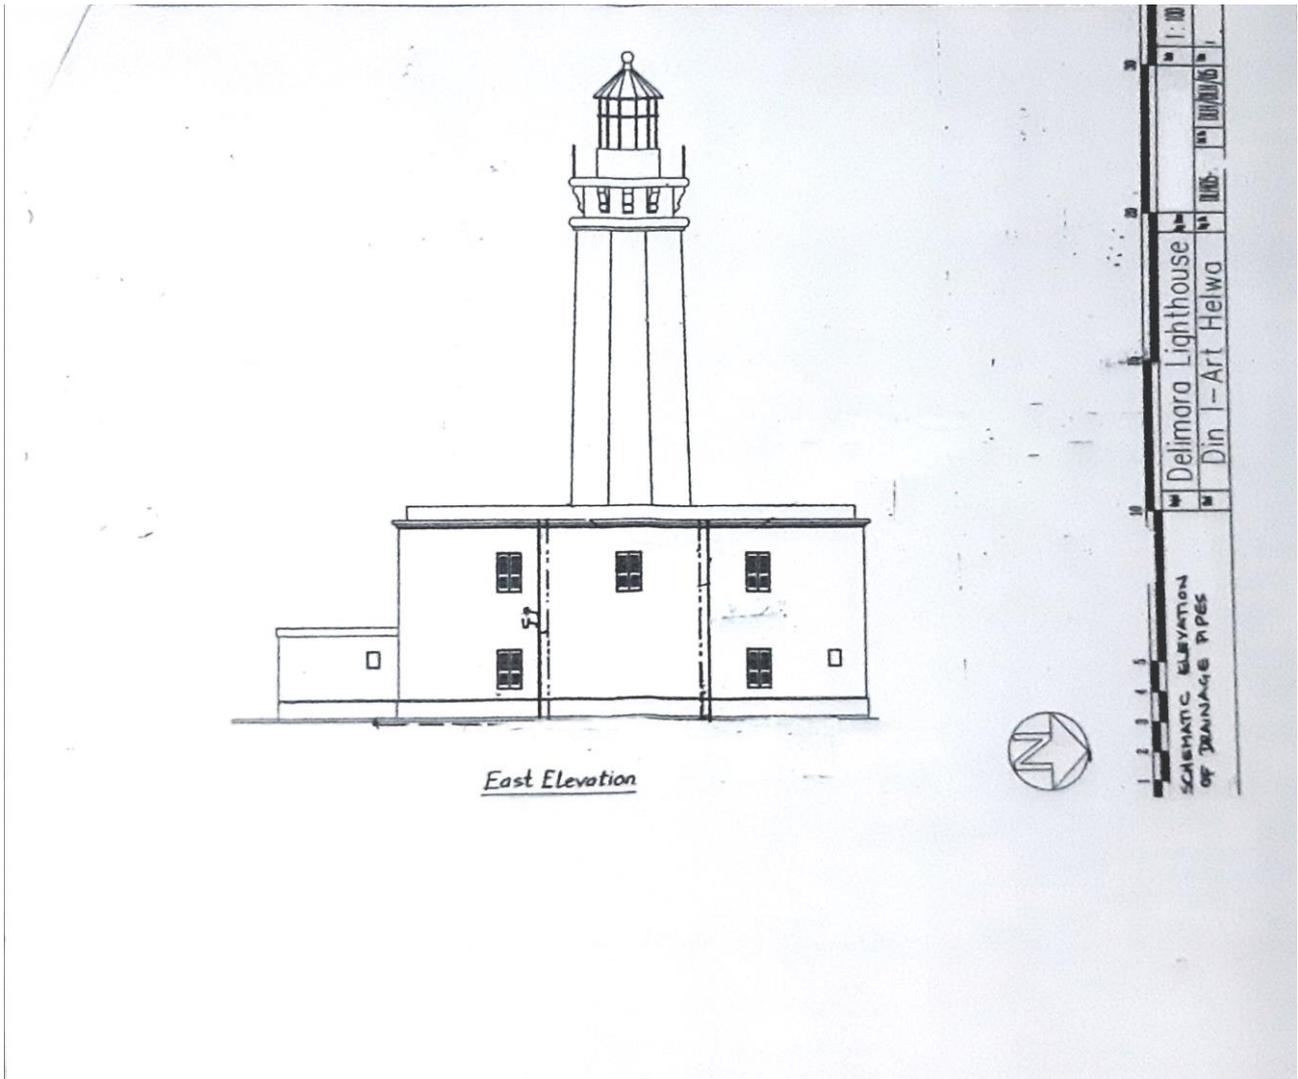
The turret is an octagon and conical in shape. It houses the stairs leading to the lantern

The methodology adopted should be as follows:
